RESEARCH MEMORANDUM

NOTE ON FLUTTER OF A 60° DELTA WING ENCOUNTERED AT
LOW-SUPERSONIC SPEEDS DURING THE FLIGHT OF A
ROCKET-PROPELLED MODEL

By William T. Lauten, Jr., and Grady L. Mitcham

May 14, 1951

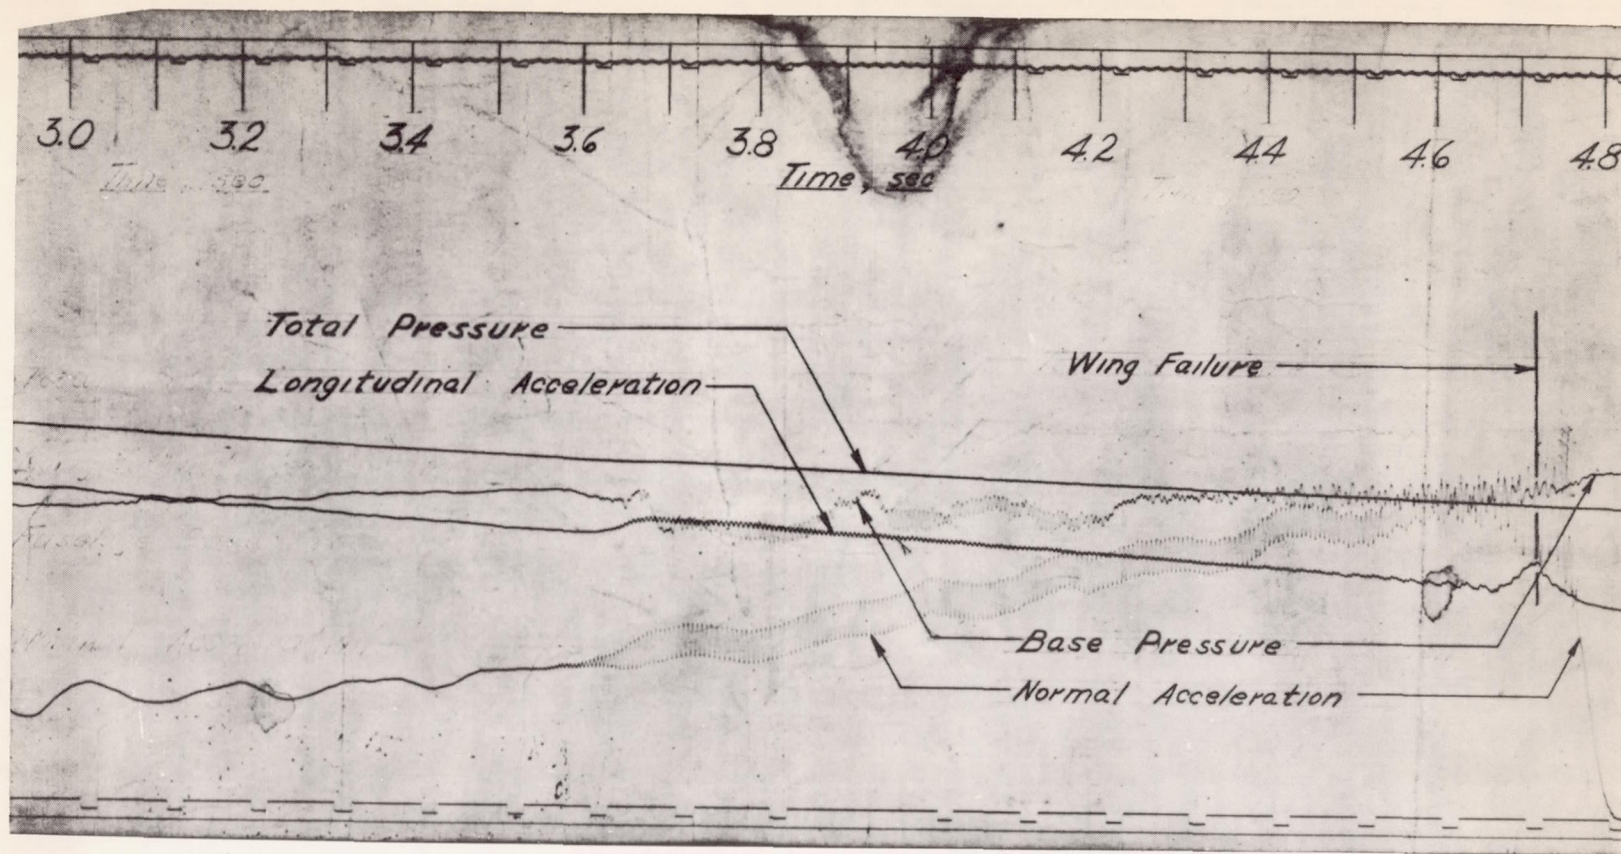
A study of the telemetered record of the flight, a portion of which is shown in figure 5, shows that a high-frequency oscillation of the normal-acceleration trace started in the decelerating portion of the flight at a Mach number of 1.11 and continued until structural failure at a Mach number of 0.99. This oscillation commenced at a frequency of 205 cycles per second and decreased to a frequency of 185 cycles per second immediately prior to wing failure. Figure 6 shows a plot of velocity and Mach number against time for a portion of the flight during which the oscillation occurred. This oscillation is believed to have been caused by wing vibration since previous experience has shown that the normal accelerometer will follow wing vibrations (references 2 and 3). Although the limitation of the instrumentation system prevents the accurate determination of amplitude at high frequencies, it may be noted that the amplitude, as recorded, indicates a normal acceleration of approximately $\pm 0.3g$. This quantity is believed to be low by a factor of approximately 16, as pointed out in the section entitled "Apparatus and Flight Tests." Thus, the oscillating load may have been in the order of $\pm 5g$.

An inspection of the flight time history shows an increase in drag at the onset of the oscillations. This phenomenon could be associated with either flutter or buffeting. Further study leads to the conclusion that it was flutter rather than buffeting. The first factor that leads to this conclusion is that the ratio of the frequency of oscillation of the wing tested in flight to the natural torsional frequency of the wing tested in the laboratory is 0.74. This value compares favorably with ratios of flutter frequency to torsional frequency which were obtained in the Langley 4.5-foot flutter research tunnel for 45° delta wings (unpublished data). Secondly, these oscillations were encountered at zero lift, and flight tests of other wings identical in plan form and section but not in construction and stiffness (references 1 and 4) gave no indication of buffeting at lift coefficients near zero, although buffeting was encountered at high lift coefficients. Thirdly, the frequency of the oscillation was more than double the first bending frequency, while in previous flight tests in which buffeting was encountered the frequency of oscillation usually has been at or near the first bending frequency.

Figure 5.- Portion of telemeter record before and during flutter of flight model.
